NVARC

Signal

October 2024

Repairing an old Swan 250C Part 1: The 117XC Power Supply

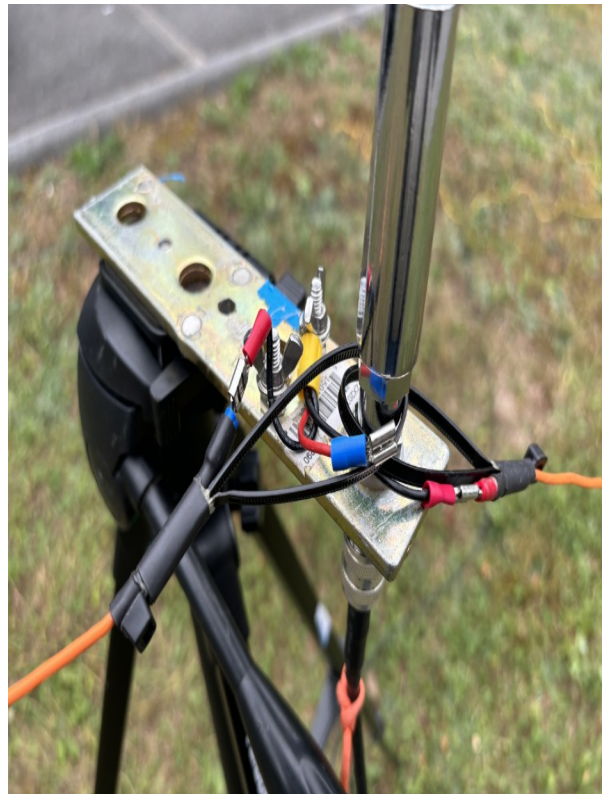
The first antenna being tested was the tripod-mounted version, with the antenna base about four feet from the ground, and tuned radials extending from the antenna to fence posts embedded in the turf. The radials were diametrically opposed to one another.

The second antenna consisted of another CB-style mount attached to a landscape timber spike, with six radials about sixteen feet long. As I "figure-8" wrap the radials for storage, they are far from straight when laid out on the ground, spaced roughly evenly. I had to swap the telescoping whip between the two setups. The constants in the experiment were the radio (KX3 running FT8 at 5W) and the feedline (about 50 feet long with five ferrites near one end as a choke).

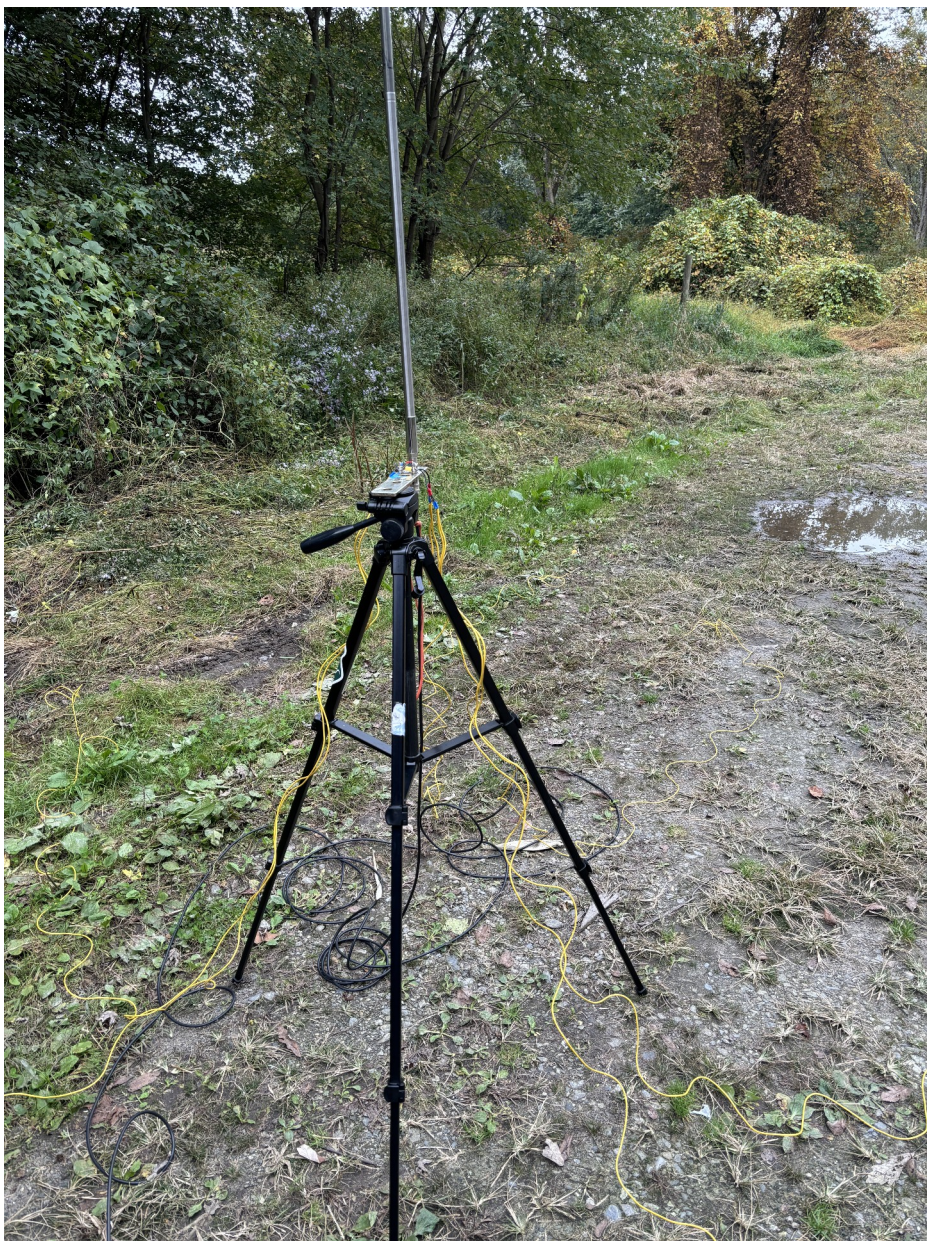
Subsequent to these "tests", I've activated other parks (always angling to increase my park count) using various configurations. The ground-mounted antenna proves to work very well, as did the elevated antenna with dangling radials. The last outing additionally produced 23 contacts on 17m after adjusting the vertical antenna length, leaving the untuned radials dangling. During one outing, yes, I neglected to even *connect* the radials. I suspect the feedline acted as a counterpoise, although there might have been incidental contact between the antenna and one of the radials. Haste does make waste. Based on 22 activations using one of these three (errr, four) antenna varieties, here are the rankings (contacts/hour):

No Radials	16
Tuned Radials	18.6
Untuned Radials	24.7
Ground Radials	24.6

But that wasn't the question posed by Carl, was it? What about random radials on a tripod? On a subsequent POTA trip, I used the same antenna, set to the same length, atop the tripod, but with the six 16 foot radials dangling down from the feedpoint, roughly four feet from the ground, then spread out on the ground. I activated three sites in close proximity near the MA-CT-RI border. At each site I operated for an hour, essentially under the same conditions as the earlier half-hour tests - mostly calling CQ using FT8.

There are so many other variables involved that most certainly influenced these results that I'd be a fool to conclude that these antennas are all even roughly equivalent. I do think there's a really general correlation, though I'd have expected the tuned elevated radials to perform better. Be assured that I'm not waving my hands around, madly proclaiming "science!".

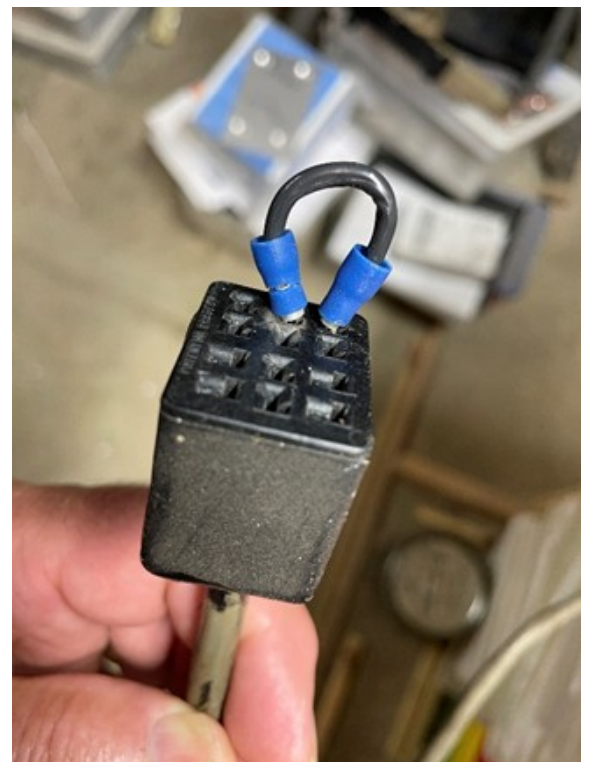
Trouble shooting now begins. Disconnect the power supply from the radio. Then jumper the two pins that go to the radio's AC power switch so the power supply can be turned on without the radio. You will need a schematic for this. In my case pins 1 and 2 on the Cinch power connector is where I added a DIY jumper wire.

Jumpering the Cinch connector

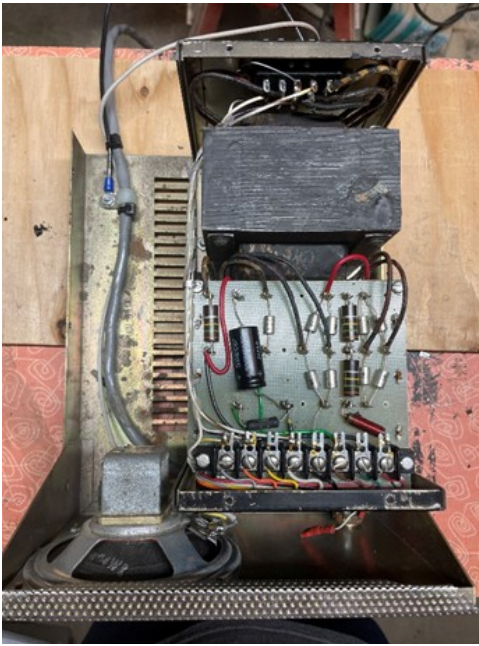
Next, I removed the top cover and the power supply chassis cover to reveal the innards of the power supply. To the right is the power supply tipped on its side.

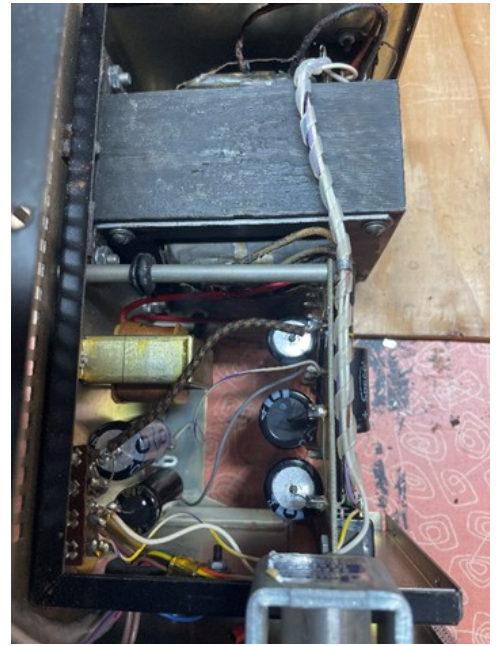
With the cover removed from the power supply I see five 100uF 350VDC electrolytic capacitors and one 150uF 150VDC electrolytic capacitor. Pictured are the replacement caps. Oops.

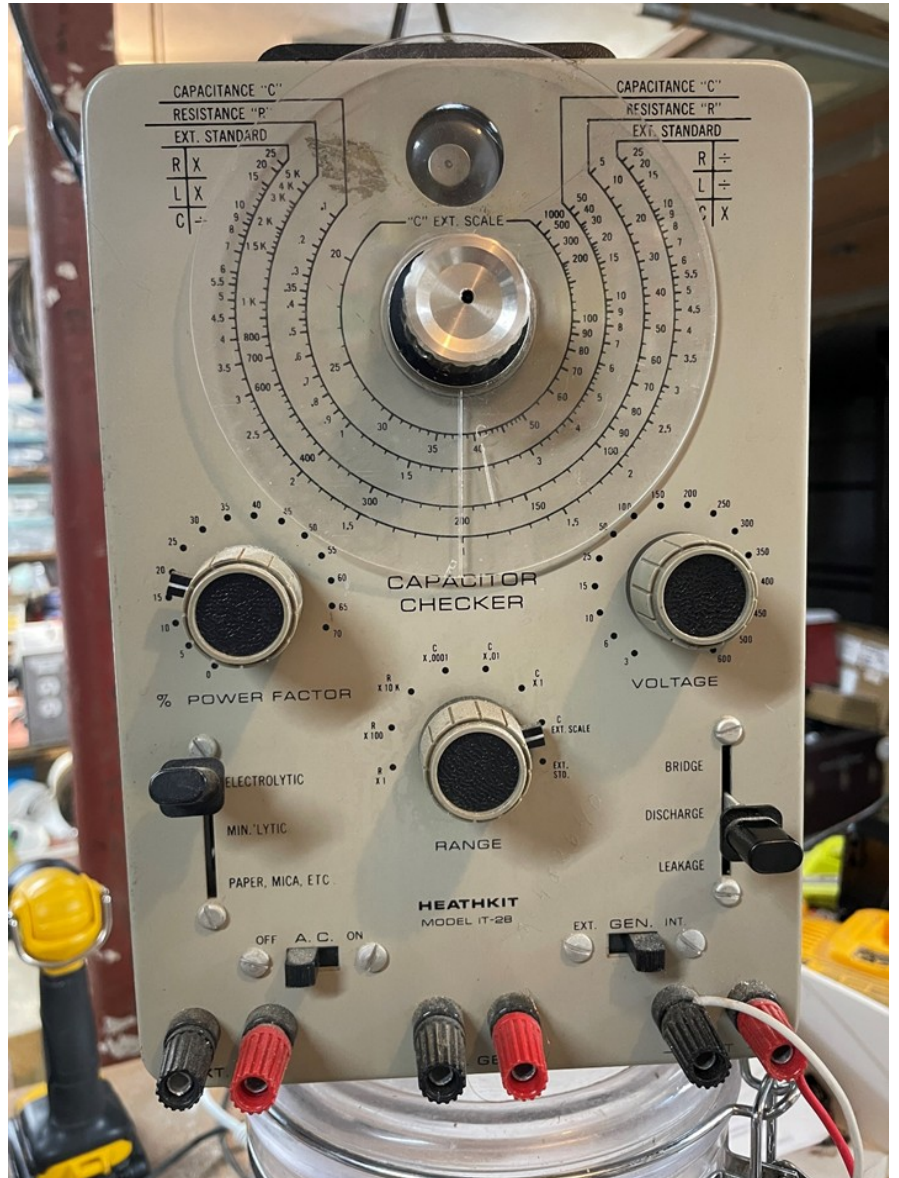
Heath IT-28 Capacitor Checker

The Magic Eye is a greenish display at the top middle of the IT-28 Unit.

Magic Eye open

Magic Eye closed

With a capacitor checker (I used a Heath IT-28) I put the negative terminal to the power supply ground and the positive to the capacitor positive lead. Turn on the IT-28 and allow it to warm up. When the magic eye (the green display on the top of the dial) spreads open the instrument is ready to use.

Initially set the vertical switch to 'Discharge' to make sure there is no DC voltage charge still present on the capacitor.

The Magic Eye should now show open. Flip the vertical switch to 'Leakage'

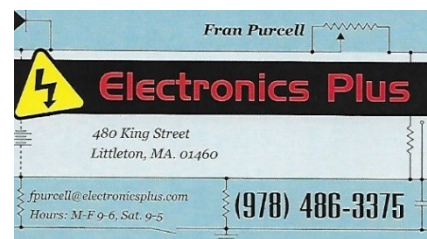
So, I went to see Fran at Electronic Plus in Littleton, MA and purchased 5 100uF 450 VDC electrolytic capacitors. (I wiped out his entire stock). I also got a 150uF 150 VDC electrolytic capacitor. All of them were axial lead capacitors, the leads come out at each end of the capacitor.

Before replacing the old capacitors with the new ones, I went ahead and checked the new capacitors on the IT-28 and reformed them to their rated voltages as I did not know how long the capacitors had been on the shelf.

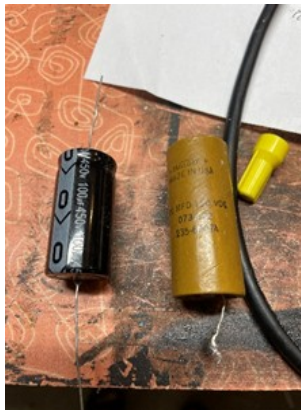
(left) The capacitor on the right is an example of an old-style electrolytic capacitor.

The one on the left is a replacement modern electrolytic capacitor. Note that the leads are polarized either positive (+) or negative (-).

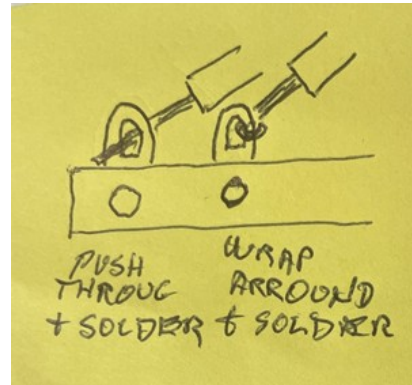
I don't like to wrap the capacitor leads around the solder lugs. I just insert them through the lugs and solder them (above right). This way in the future you can easily remove the components. Trim the excess lead with the wire cutters.

Before I removed the old capacitors I marked where the capacitor Positive (+) leads are located. I made a note on the chassis or the Printed Circuit Board (PCB) with a 0.5 Sharpie Pen. Cut the old capacitor leads at the body of each capacitor leaving $\frac{1}{2}$ in of lead on the soldering lugs. Then use a solder sucker tool to remove any solder from the terminal lugs. With care use both a small wire cutter and a stiff needle nose pliers to remove the leads from the solder lugs. Care is needed because if you break a solder lug you will have a lot more work to do replacing the whole solder terminal. Once the capacitor leads are removed from all the concerned solder lugs, start replacing the new capacitors, being very careful to maintain polarization.

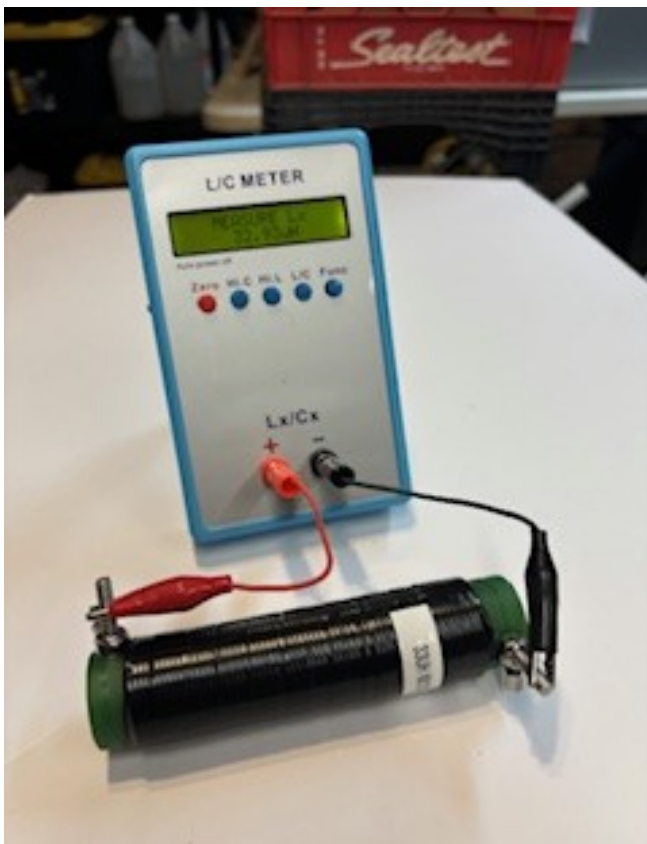
A simple loaded vertical antenna

Tim devised a center-loaded vertical for 20 and 40 meters. The lower 20m portion is a 200.5” (~quarter-wave on 20m) wire. The coil is placed between that wire and another wire roughly 51” long to match 40 meters.

Trim for VSWR. This is a quarter-wave antenna so no matching network is needed, but perhaps a choke somewhere along the feedline would be helpful? I used a BNC to binding post adapter and laid out six radials. The antenna was supported by a telescoping fiberglass mast.

And it works. It tuned up nicely on 20 and 40m, VSWR down around 1.2 (OK, I didn’t tune it). It also worked on 10m, and I was quite surprised that it tuned up and worked on 15m. 36 POTA contacts in 90 minutes.

Next month there will be an article on making coils like this 33uH example wound with 22ga solid insulated wire on a poly core from a roll of produce bags at the market.
